Test Report

Report No.:H202205232508-01EN

Sample Name: TC50 Controller

Reference
Document: MIL-STD-810G

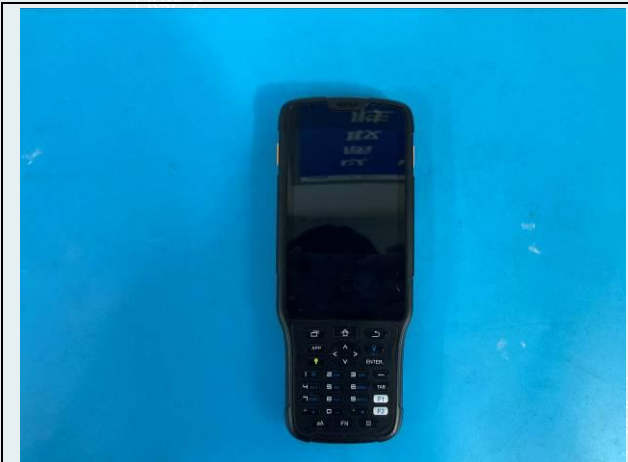
<p>Fig.1-1 Samples before test</p>	<p>Fig.1-2 Samples after test</p>

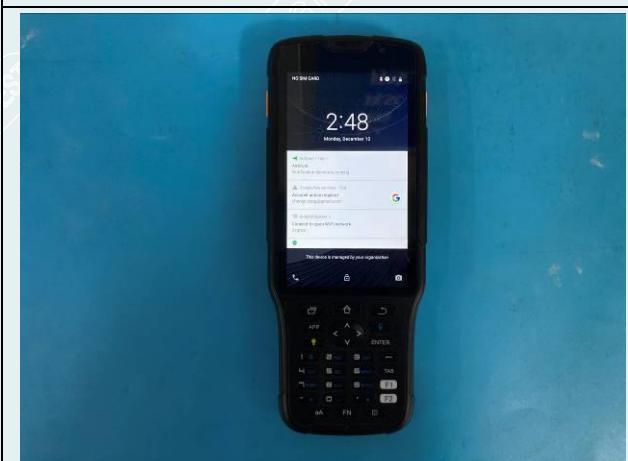
<p>Fig.1-3 Functional check before test</p>	<p>Fig.1-4 Functional check after test</p>

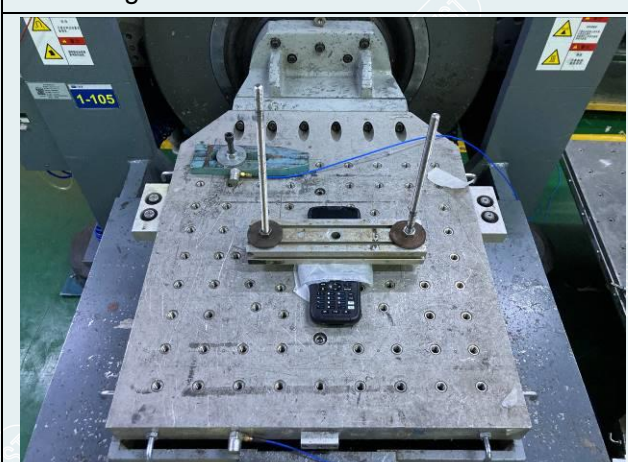
<p>Fig.1-5 The test sample sets up the Transverse-axis</p>	<p>Fig.1-6 Vibration curve(Transverse-axis)</p>

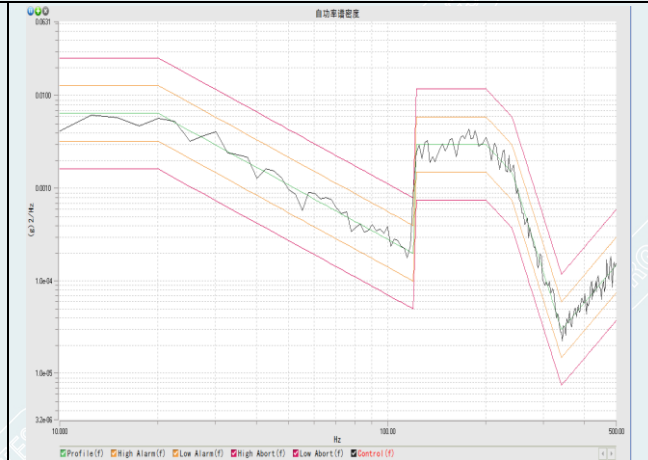
Fig.1-8 Vibration curve(Longitudinal-axis)

Vertical		Transverse		Longitudinal	
Frequency,Hz	PSD,g ² /Hz	Frequency,Hz	PSD,g ² /Hz	Frequency,Hz	PSD,g ² /Hz
10	0.015	10	0.00013	10	0.00650
40	0.015	20	0.00065	20	0.00650
500	0.00015	30	0.00065	120	0.00020
Rms=1.04g		78	0.00002	121	0.00300
		79	0.00019	200	0.00300
		120	0.00019	240	0.00150
		500	0.00001	340	0.00003
		Rms=0.20g		500	0.00015

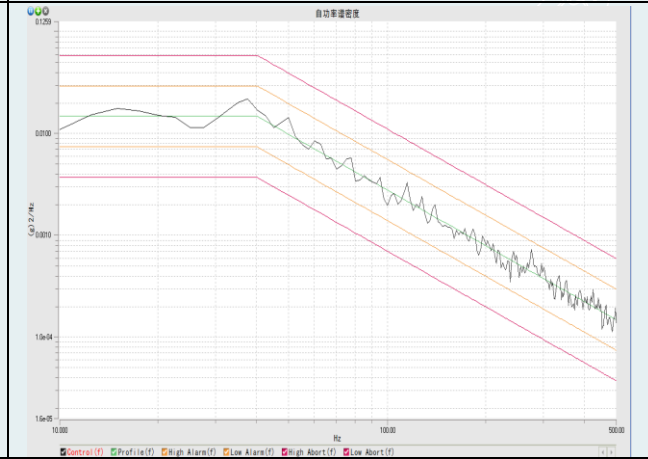
Fig.1-10 Vibration curve(Vertical-axis)
